# Air Permeability and Thermographic Analysis Report

Project-OECOTOP Building Systems

20A Baskin Cottages  
Cloghran,  
Co. Dublin.

Date: 11<sup>th</sup> & 12<sup>th</sup> August 2007

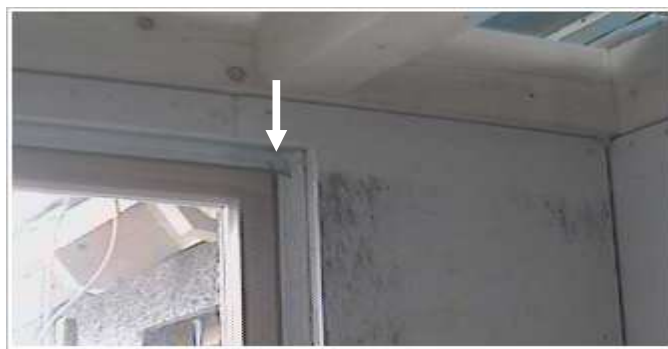
Note: In this instance internal temperatures at the time of the survey ranged from 18°C -19°C. Outside temperature = 18°C. Due to the small differentials in temperature the infrared image capture of infiltration was attainable but did not provide for sharp imagery. Arrows indicate the infiltration points.

**Figure 3 West Window – Infrared (Iron)**

**Figure 4 West Window – Infrared (Rainbow)**

**Figure 5 West Window – Visible**

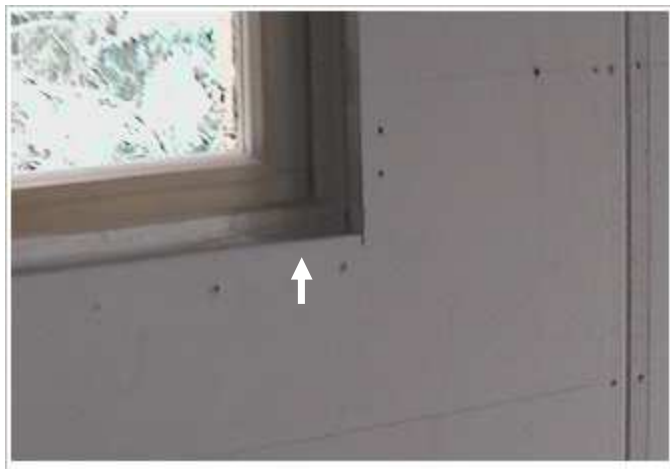
**Figure 9 East window left hand side – Infrared (Iron)**

**Figure 10 East window left hand side – Infrared (Rainbow)**

**Figure 11 East window left hand side – Visible**

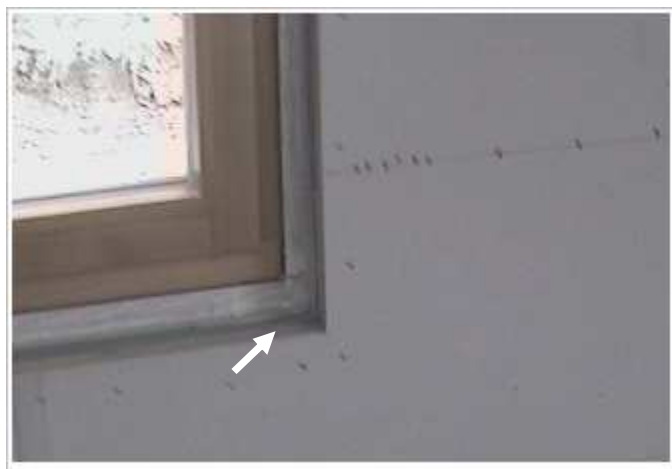
**Figure 12 East window right hand side - Infrared (Iron)**

**Figure 13 East window right hand side - Infrared (Rainbow)**

**Figure 14 East window right hand side - Visible**

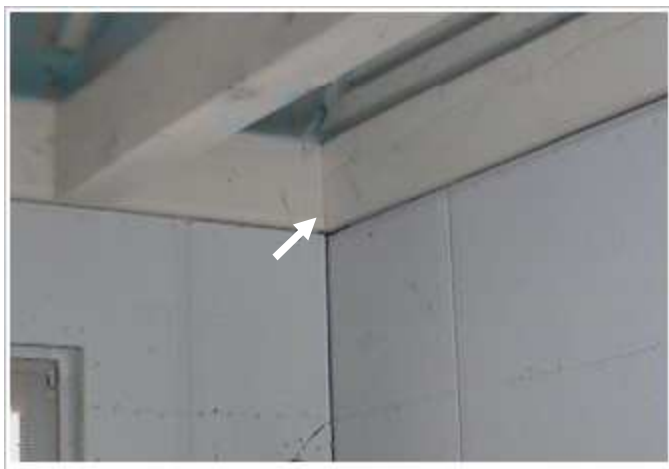
**Figure 15 South East Top Corner – Infrared (Iron)**

**Figure 16 South East Top Corner – Infrared (Feather)**

**Figure 17 South East Top Corner – Visible**

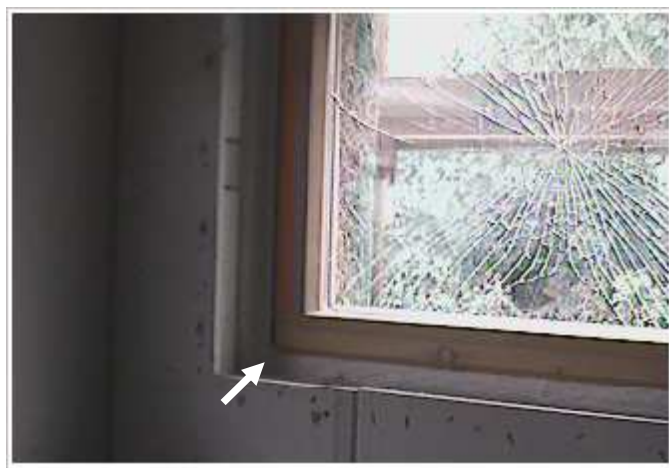
**Figure 20 East Windows North Corner – Infrared (Iron)**

**Figure 21 East Windows North Corner – Infrared (Rainbow)**

**Figure 22 East Windows North Corner – Visible**

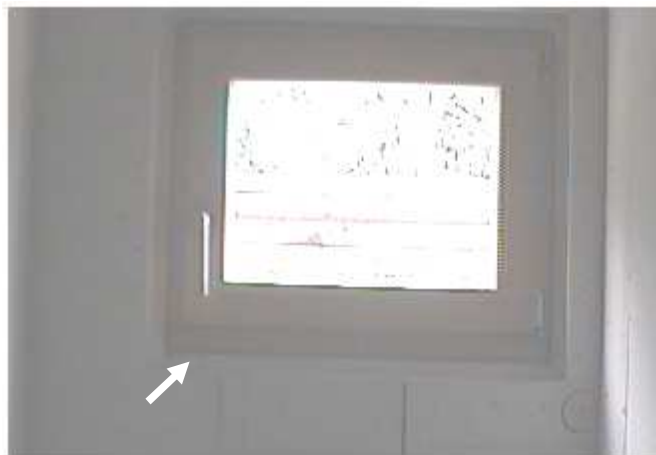
**Figure 23 Utility Window – Infrared (Iron)**

**Figure 24 Utility Window – Infrared (Rainbow)**

**Figure 25 Utility Window – Visible**

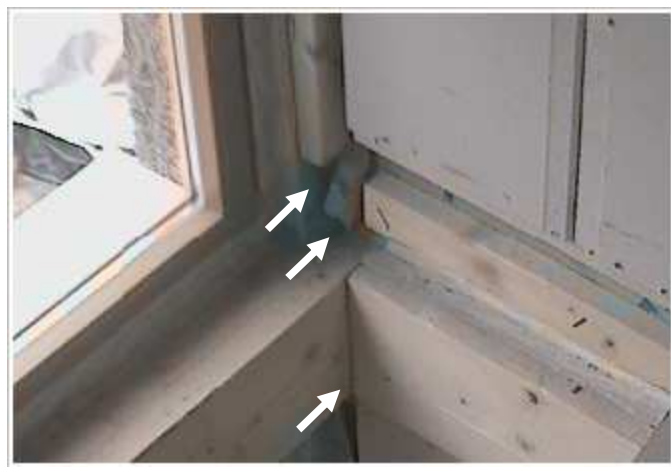
**Figure 26 South West Corner Floor Level – Infrared (Iron)**

**Figure 27 South West Corner Floor Level – Infrared (Rainbow)**

**Figure 28 South West Corner Floor Level – Visible**

- 1) Roof space – works ongoing
- 2) Window frames – works ongoing

Any remedial works to be done by Project-Oecotop.
